BRIDGE INSPECTION REPORT

SHERMAN MINTON BRIDGE I-64 OVER THE OHIO RIVER

BRIDGE NO. I-64-103-4961B

NOVEMBER 2007

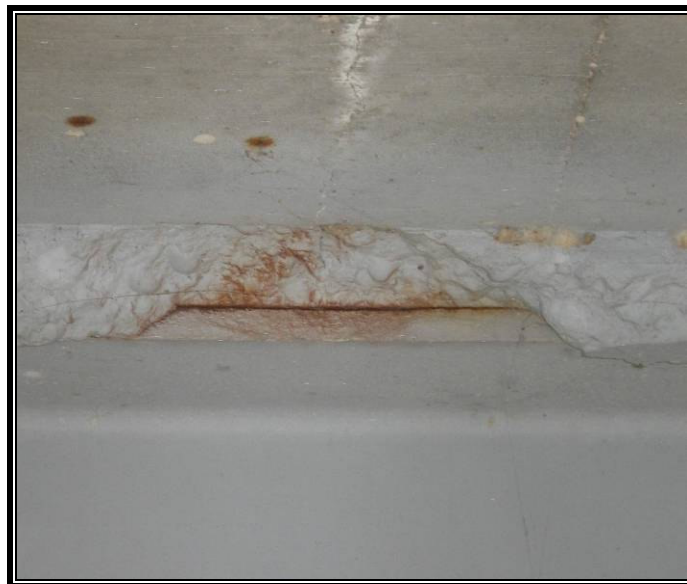
58.02 Deck - Underside: The underside of the westbound deck has some small spalls ($<1 \text{ ft}^3$) and minor widespread transverse and map cracking with efflorescence. The areas on the underside of the eastbound deck, which were visible from the inspection walkway, showed minor to moderate spalling of the stringer haunches, as well as minor widespread cracking with efflorescence.

Photo 58.02: Typical spalling of stringer haunch

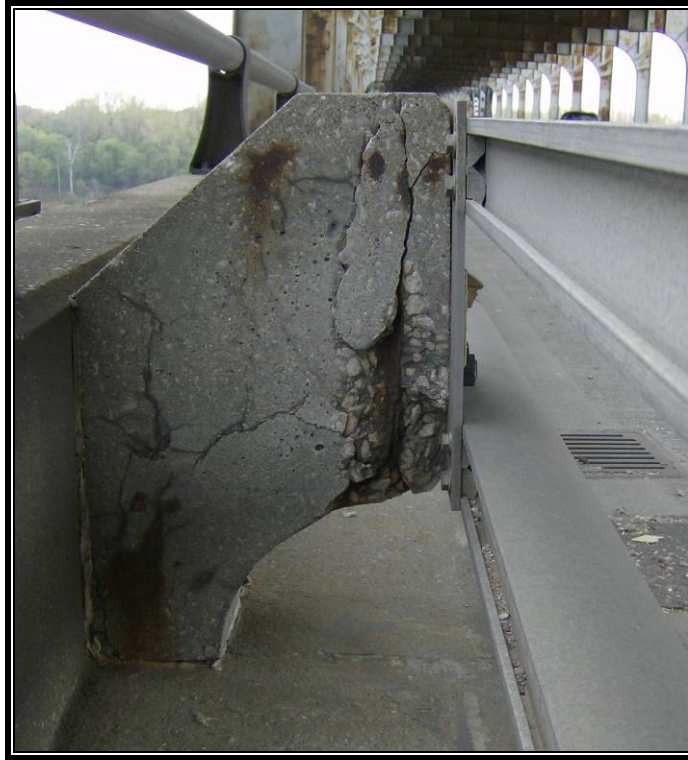
Photo 58.08a: Cracking and spalling in railing support on eastbound deck

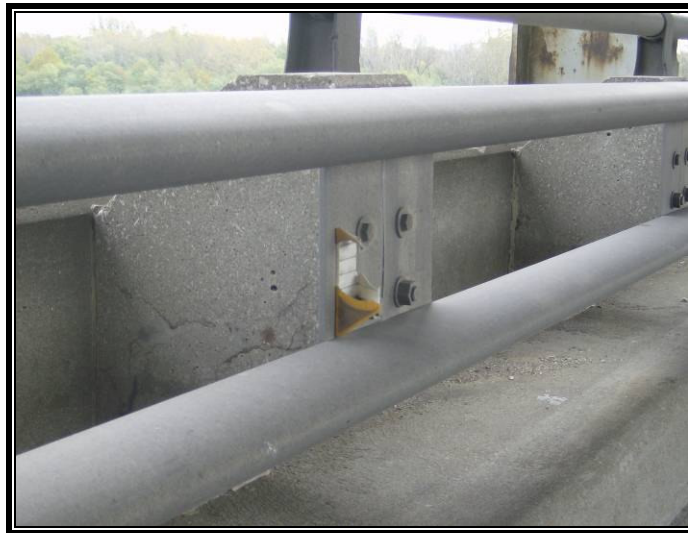
- 58.03 Curbs:** The curb faces on the westbound deck have minor widespread spalling. The curb faces on the eastbound bridge are in good condition.
- 58.08 Railing/Post:** Many railing supports have minor to moderate cracking. Several have small spalls near the connection to the railing (see Photo 58.08a). In addition, many edge reflectors on the eastbound deck are broken or missing (approximately 10-15% of the yellow markers and 15-20% of the white markers) (see Photo 58.08b).

Photo 58.08b: Broken edge reflector on eastbound deck

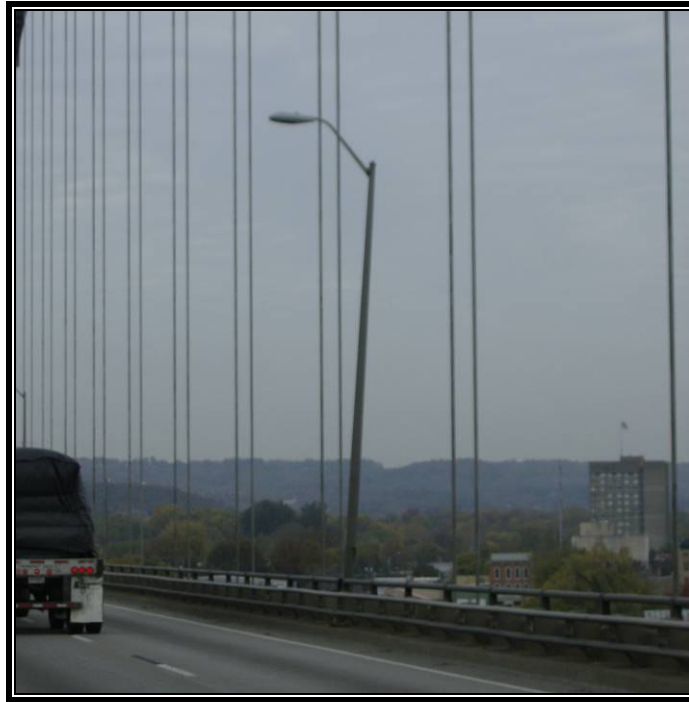
- 58.10 Drains:** The drains are in fair condition due to excessive buildup of debris. There are approximately 13 clogged drains on the westbound deck and 2 clogged drains on the eastbound deck.
- 58.12 Lights:** A light pole on the north side of the westbound deck in Span 2 near Panel Point 6 which is bent outward over the river (see Photo 58.12).

Photo 58.12: Bent light pole in Span 2 near Panel Point 6

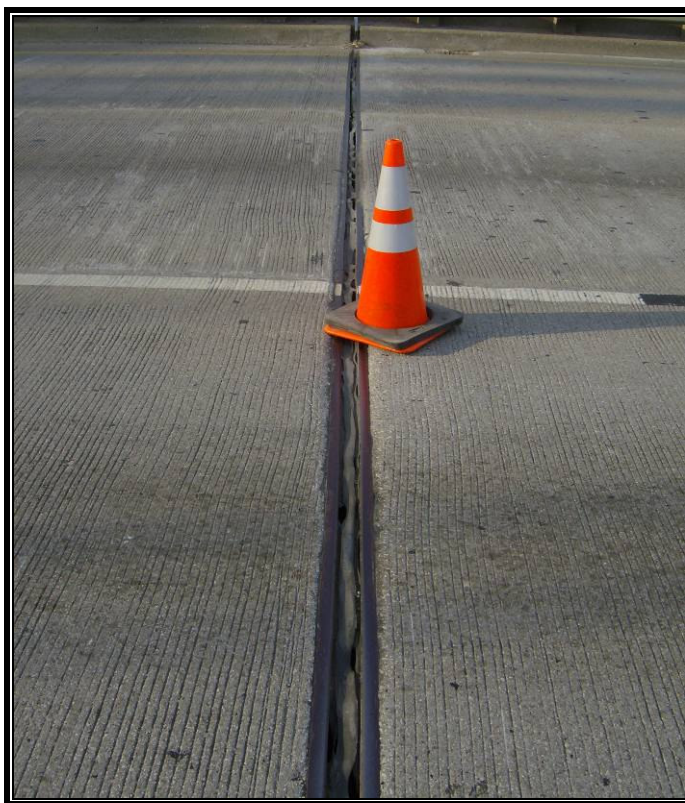
The seals in the expansion joints of the westbound deck at Panel Point 11 in Span 1 and Span 2 have failed completely. The seals have been torn away from the armored edges (see Photo 58.16). The joint in the eastbound deck at Pier 7 is exhibiting similar problems, though the seal is still mostly intact.

Photo 58.16: Failed expansion joint at Panel Point 11 in Span 1

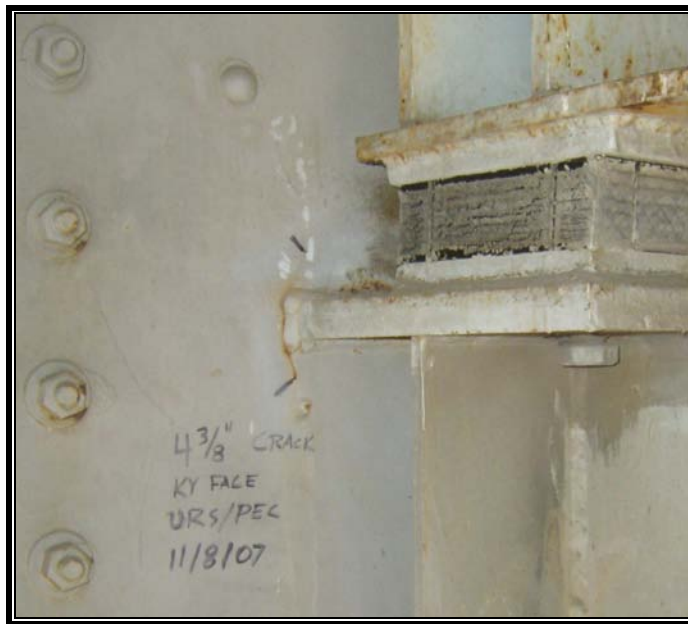
- There is heavy surface rust and minor pitting on the top flange of the cross girder and top flange stiffening plate at Pier 9.
- There is a $6\frac{1}{8}$ " crack in the angle connecting the fourth stringer from the south to the west face of the cross girder at Pier 8. This crack was found in 1992 and does not appear to be active.
- There is a $4\frac{3}{8}$ " crack in the east face of the cross girder web at Pier 8 at the support connection for the fourth stringer from the south (see Photo 59A.02).

Photo 59A.02: Crack in east face of cross girder web

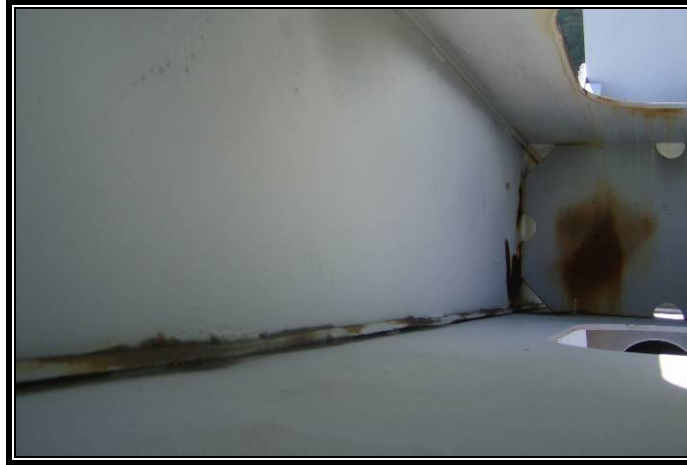
Backer rods are tack welded to many of the truss arch members. These tack welds can create stress risers in the truss arch members. Many of them have broken, leaving the backer rods loose inside the members. Currently, minor pack rust has formed between some of the backer rods and truss arch members (see Photo 59A.12).

Photo 59A.12: Pack rust between backer rod and truss arch member

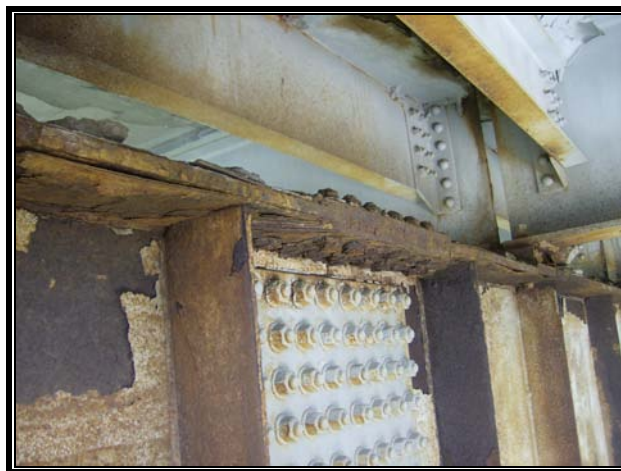
59A.16 Floorbeams: The floorbeam under the expansion joint at Panel Point 15 in Span 1 has heavy rusting and minor loss of section on the top flange and splice plates (see Photo 59A.16).

Photo 59A.16: Deterioration on floorbeam at Panel Point 15

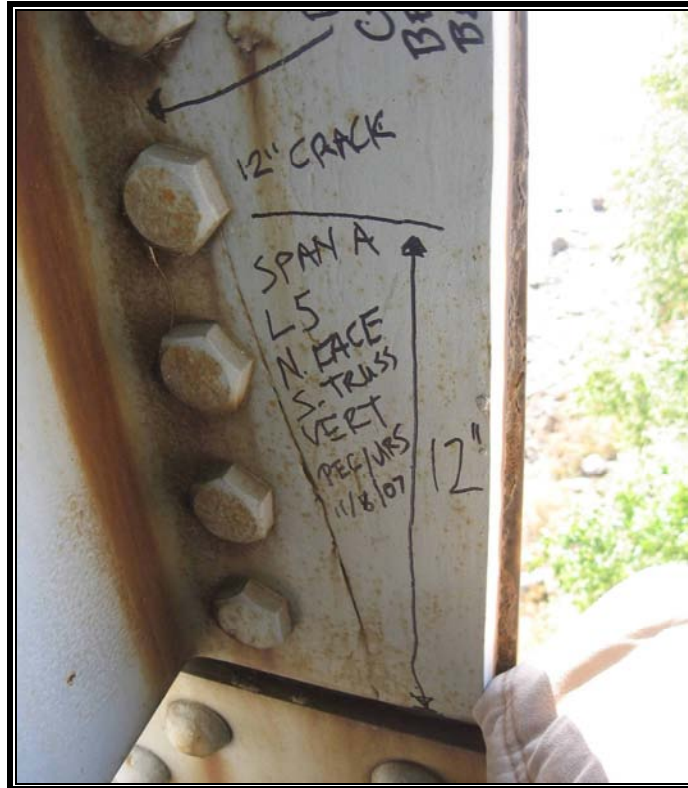
A previously found crack in the downstream vertical at panel point L5 in Span A measured 12 inches. From visual inspection, it appears that the crack has extended beyond the fourth bolt (end of crack in 1992) approximately 1 inch.

Photo 59A.18: Crack in south flange of vertical at L5 on south truss

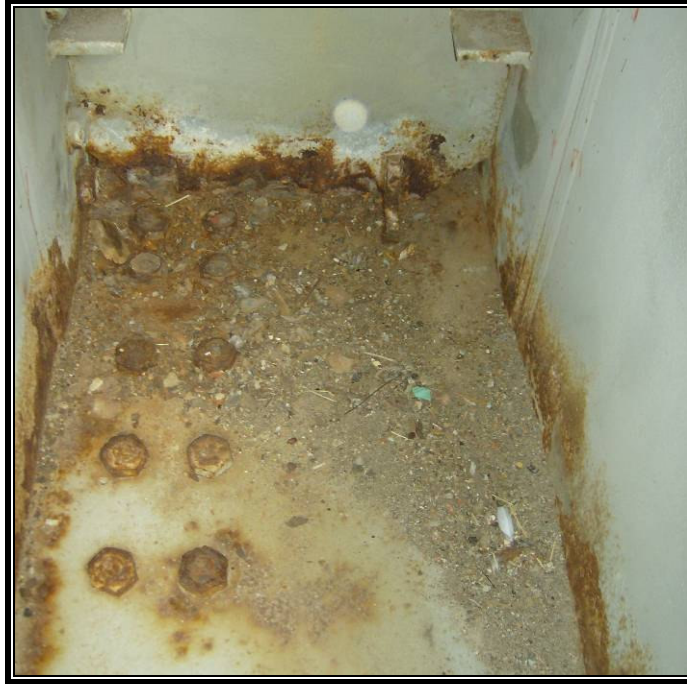
The tie chords are in fair condition. Typical conditions include crack indications in the tie chords welds, moderate rusting and flaking of the paint, isolated areas of active corrosion, and debris accumulation (see Photo 59A.23a).

Photo 59A.23a: Debris and rusting bolts inside connection at T11 on the north tie

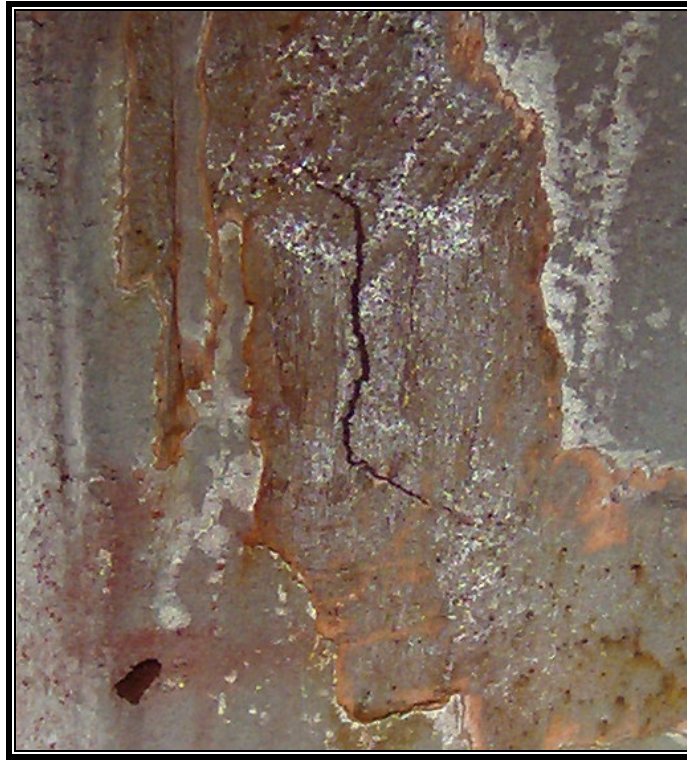
Indication 2005: South Tie Chord, Span 2, East of T12, South Face, North Plate

- 1999 – Approx. 1¼” long crack indication, 1” deep
- 2004 – MT indicated that the crack has extended ¾” toward the base metal at an approximate 45 degree angle at both ends. UT indicated that the crack is approximately 1” deep on the longitudinal section and approximately ¼” in the diagonal portions
- 2006 – MT indicated that the crack as 1⅛” long longitudinally and ⅜” long on the 45 degree angles at both ends. UT indicated that the crack is approx. ¾” deep on the longitudinal section. Radiograph test was performed at the indication to have a permanent record of the defect
- 2007 – MT indicates that the crack as 1⅛” long longitudinally, ¼” on the top left arm, and ¾” long on the bottom right arm, and 1¼” deep
- The crack remains in the weld and has not extended into the base metal
- No repair has been done at this location

Photo 59A.23b: Crack indication 2005

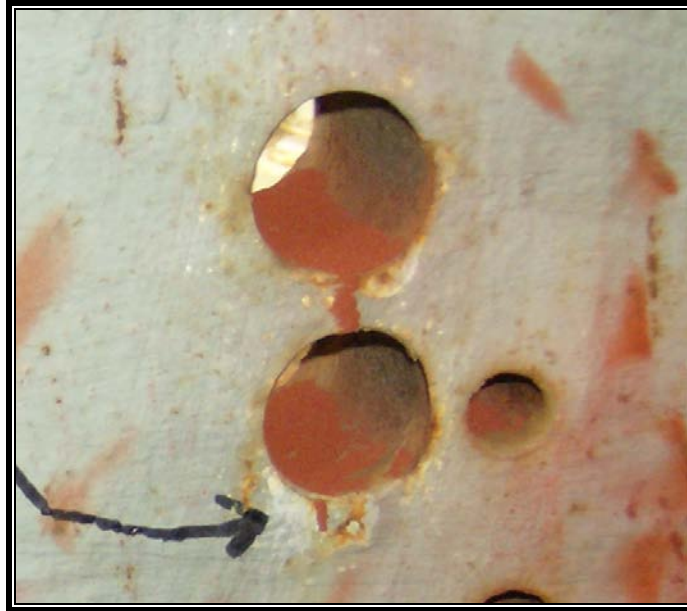
Indications 3003 & 3004: North Tie Chord, Span 1, East of T17, South Face, South Plate

- 2007 – Unable to verify crack indication (3003), originally found in 2006. However, a new $\frac{3}{16}$ " longitudinal indication (3004), measuring 1.3" deep according to ultrasonic testing, was found at the bottom of a previously drilled hole.

Photo 59A.23c: Crack indication 3004

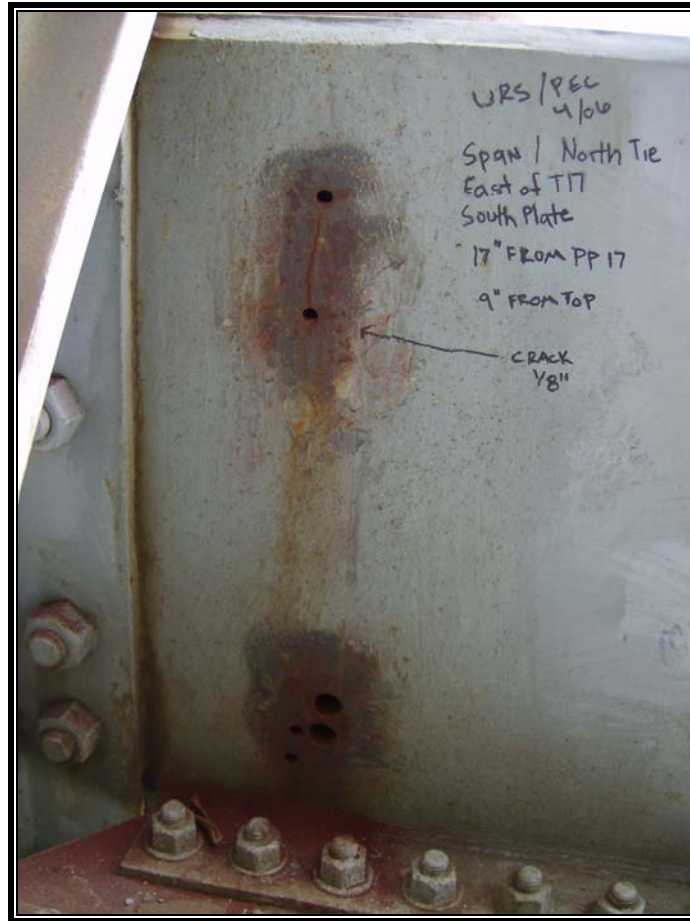
Photo 59A.23d: Crack indications 3003 (top), 3004 (bottom right), and 3005 (bottom left)

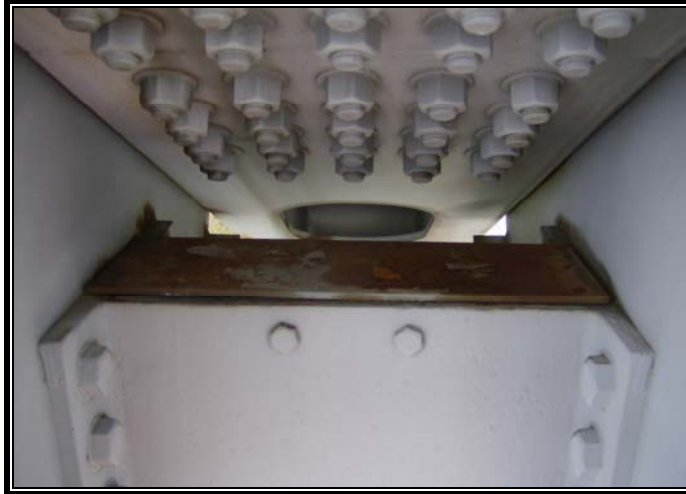
The top cable hangers are in fair condition. It appears that water is penetrating the top cover plates and causing minor to heavy surface rust on the keeper plates, typically inside the drain hole. This condition was observed on nearly all of the top cable hangers. In the worst locations, the corrosion has extended onto the outside of the keeper plates and formed pack rust between the plates, sockets and castings (see Photo 59A.41a thru 59A.41c).

Photo 59A.41a: Top cover plate on top cable hanger

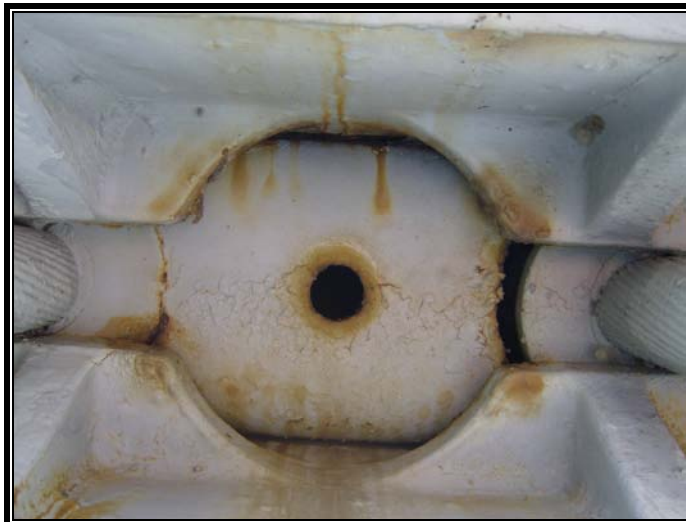
Photos 59A.41b: Typical condition of top cable hanger

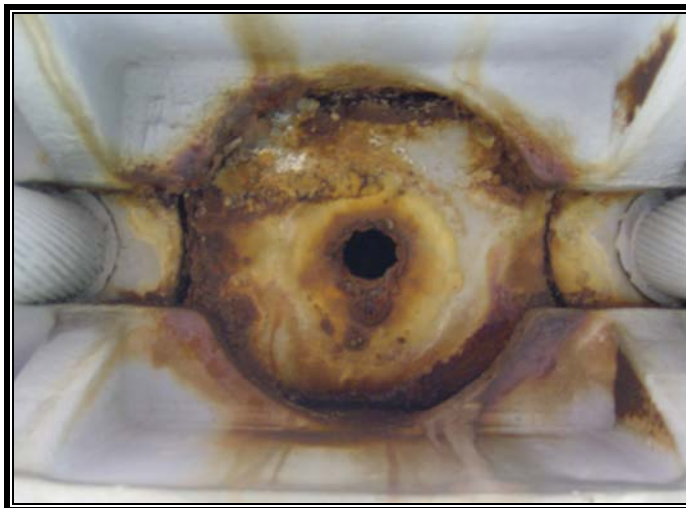
Photos 59A.41c: Heavy rusting on top cable hanger at Panel Point 8 in Span 1
